MSC-07007

APOLLO 16

30-DAY FAILURE AND ANOMALY LISTING REPORT

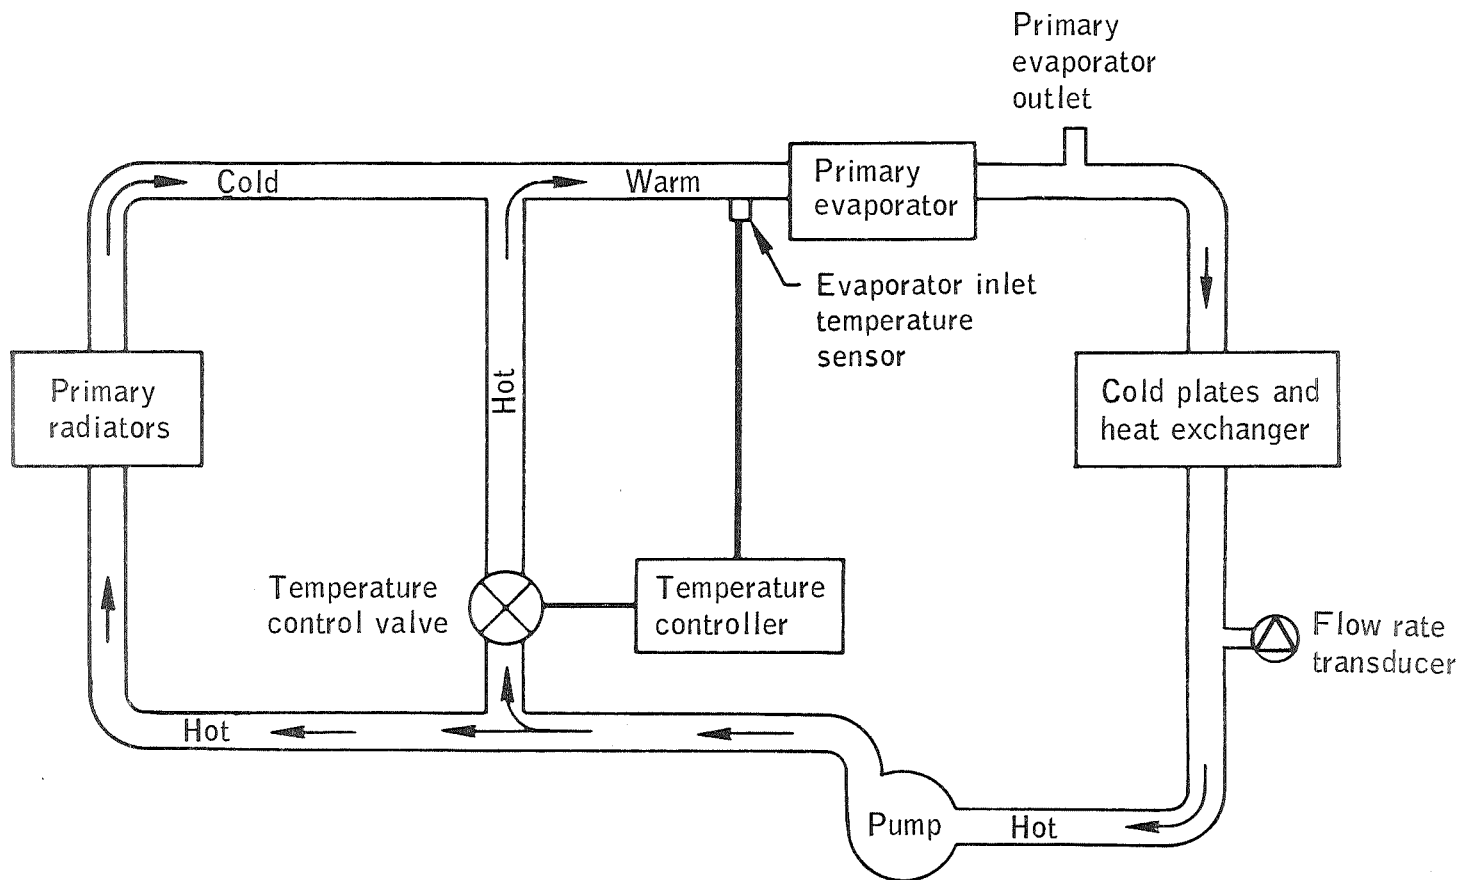
Figure 2-1.- Primary water/glycol coolant loop.

About 3 hours into the mission, the water/glycol temperature control circuit (fig. 2-1) malfunctioned in the automatic mode. The malfunction allowed an excessive amount of hot water/glycol to bypass the radiator causing the mixed water/glycol temperature to exceed the upper control limit of 48° F. After remaining in this maximum bypass position for 5 minutes, the temperature control valve cycled regularly between maximum and minimum flow to the radiators for about 14 minutes before stopping again at maximum bypass. The control was changed to manual and back to automatic to restart the valve operation and, finally, left in manual at the desired valve position. Variations in the evaporator outlet temperature and total system flow rate for the period are shown in figure 2-2. Control valve operation is evident from the variation of system flow rate. Total flow rate increases as the flow control valve opens since the total system pressure drop decreases.

Most likely, a malfunction occurred in the water/glycol temperature controller which modulates the control valve by supplying signal pulses with a duration proportional to the error of the mixed temperature sensed.

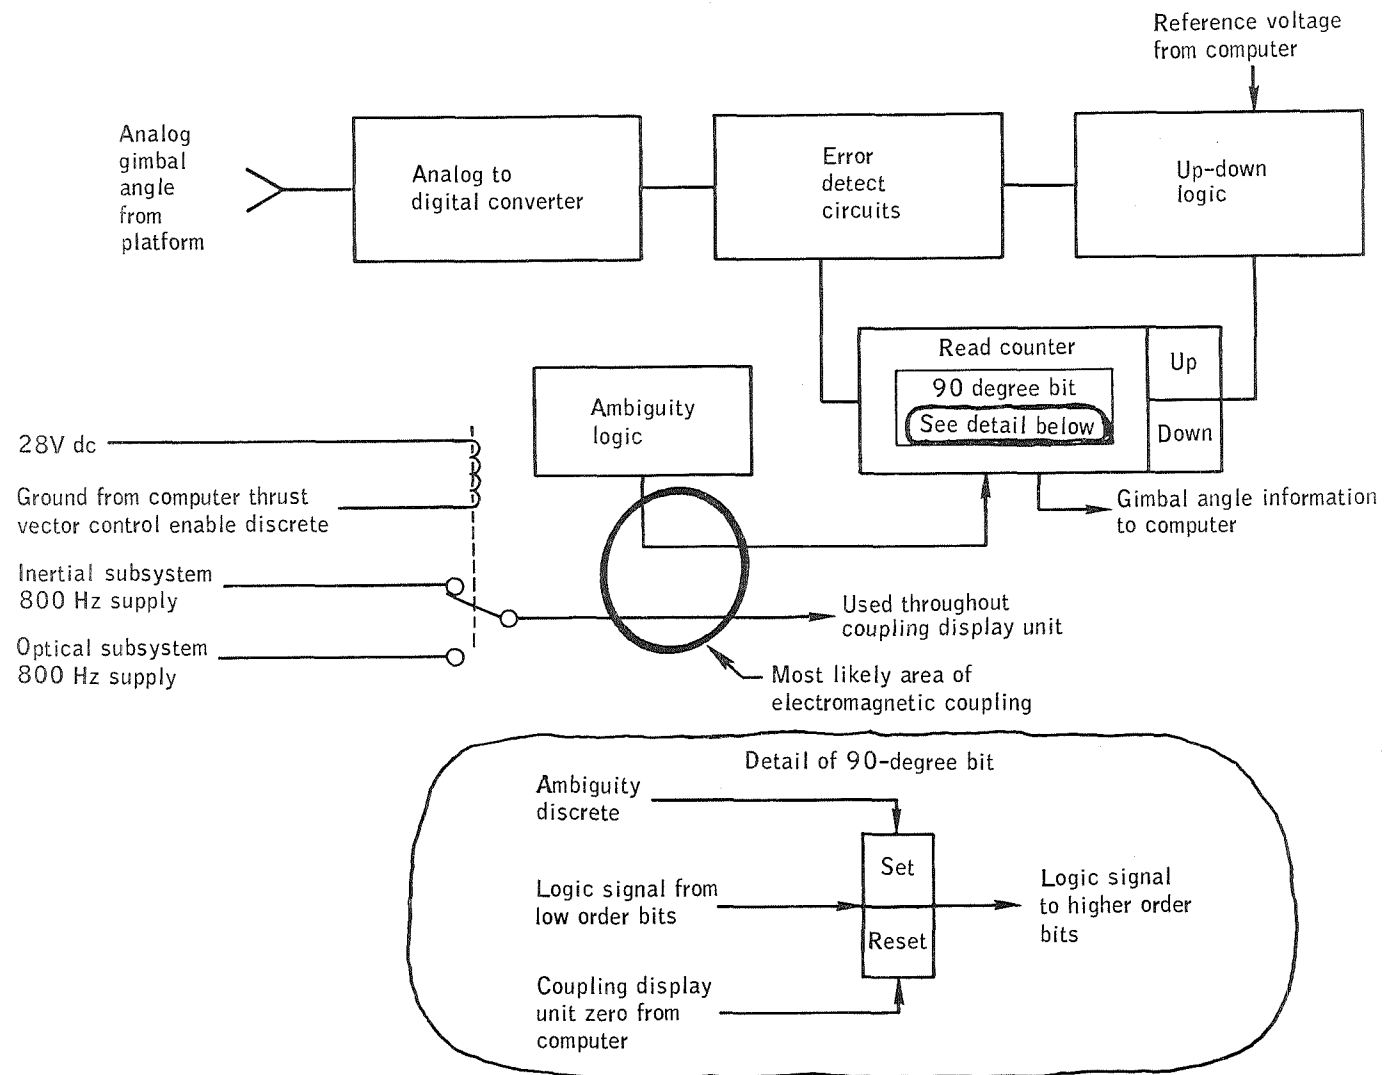
Figure 2-4.- Coupling display unit functional diagram.

Figure 2-4 is a simplified representation of the pertinent circuits in the middle gimbal angle coupling display unit. The purpose of the read counter is to store, in digital form, the platform gimbal angle. If the gimbal angle changes, the analog signal is no longer the same as the digital signal from the read counter and the resulting error signal causes a pulse train to be generated. The pulse train increments or decrements the read counter until it matches the analog gimbal angle. The read counter is a series of flip-flop logic circuits whose only inputs are a pulse train and timing pulses. The 90-degree bit is unique, however, because it can also be set by an ambiguity discrete. The purpose of the ambiguity discrete is to prevent the platform from going to an ambiguous position when the inertial measurement unit is turned on.

The cause of the problem was an erroneous ambiguous discrete which set the 90-degree bit in the middle gimbal angle read counter. The discrete was apparently caused by a transient generated when the 800-hertz excitation voltage was switched from one source to another. A transient caused by switching power sources is highly improbable since it is dependent upon timing of the relay activity in relation to the 800-hertz voltage.

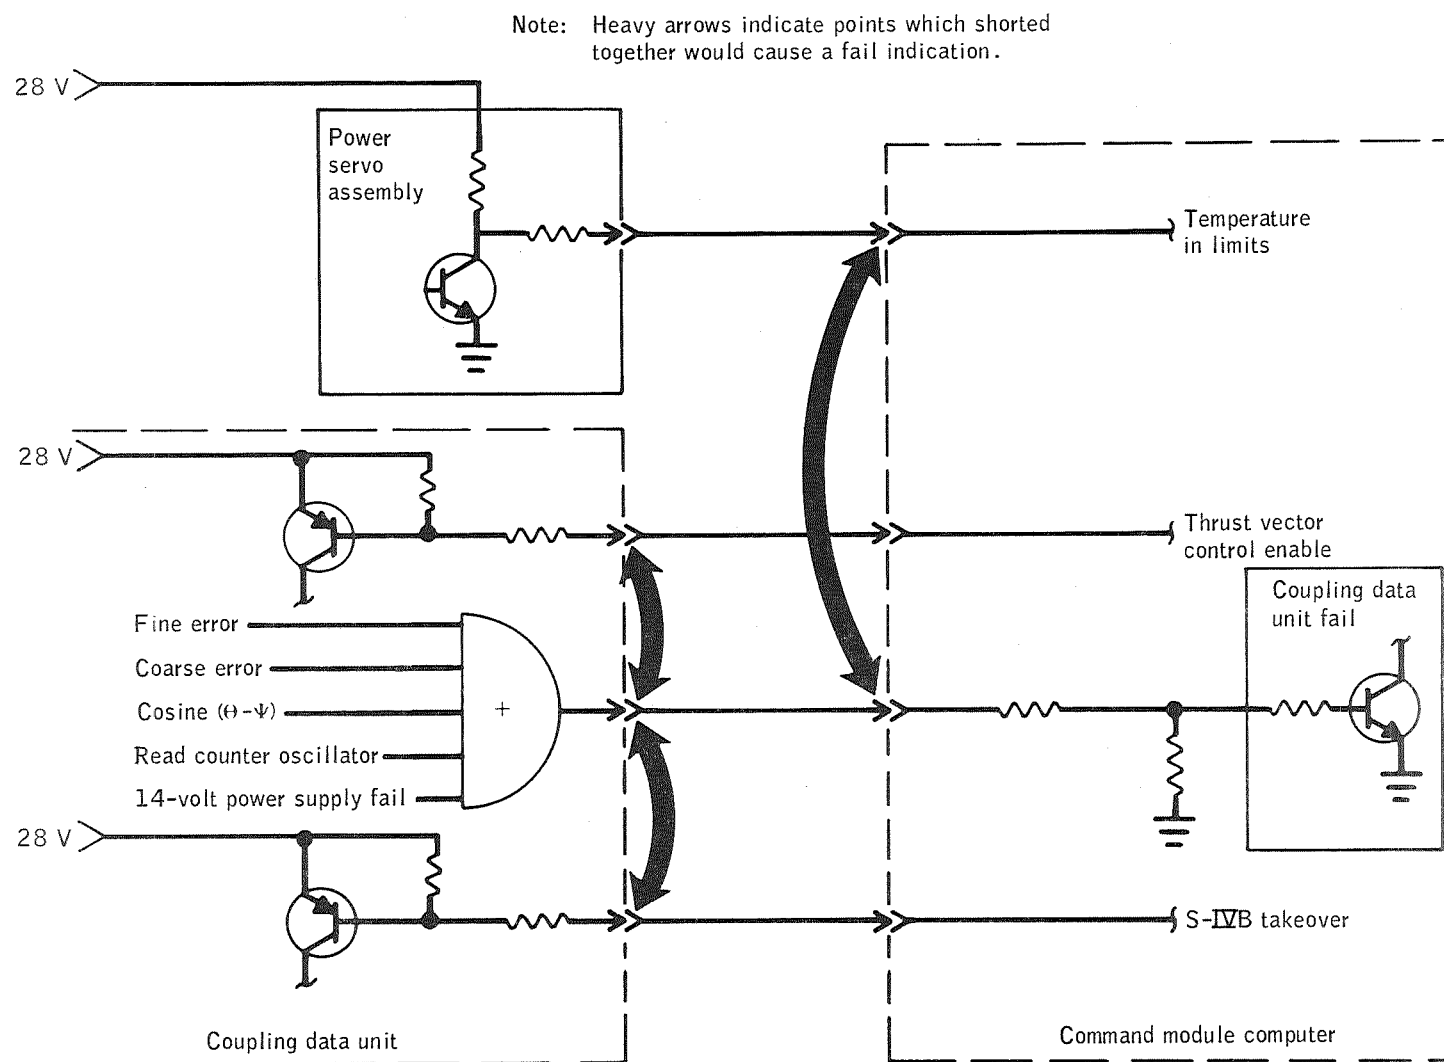
Figure 2-5.- Coupling data unit fail indication.

The time delay associated with the failure discrete to the computer was measured in flight as approximately 5 seconds. The failure indications persisted for 4, 12, 16, 894, 10, and 38 seconds, respectively.

Data during each occurrence has been reviewed and no abnormalities were observed. If a real failure of the coupling display unit had occurred and lasted as long as 894 seconds, then some data indication should have been observed. For this reason, an intermittent short in the wiring harness or associated connectors shown in figure 2-5 is suspected. However, other possible causes may be an intermittent in the failure detection logic circuits or the input logic to the computer.

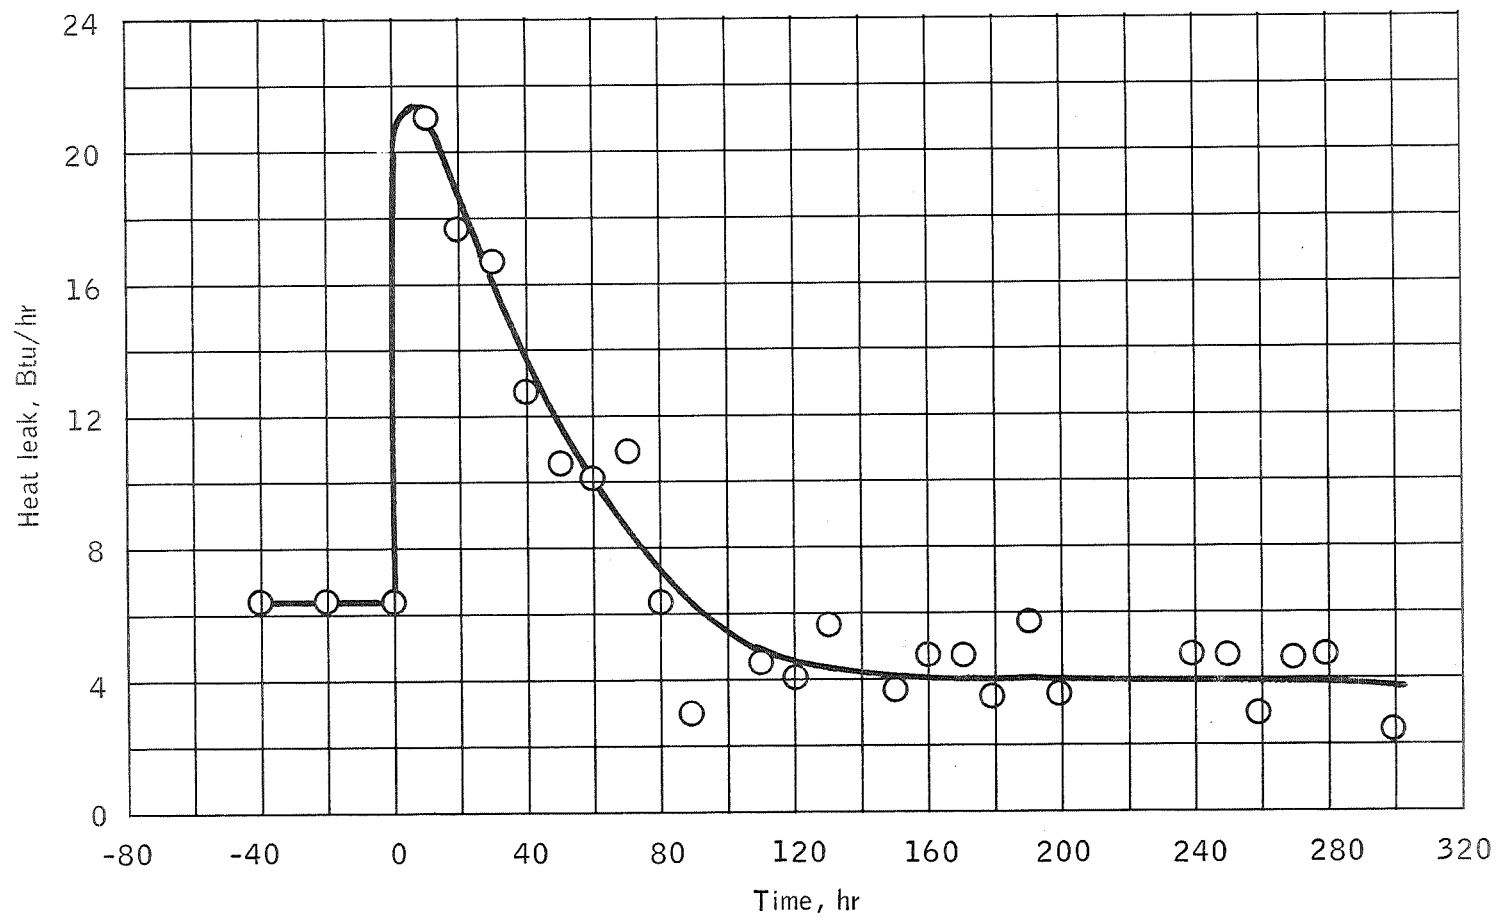
Figure 2-6.- Hydrogen heat leak data.

The heat leak into cryogenic hydrogen tank 3 was abnormal during the early hours of the mission. Analysis of the Kennedy Space Center data has shown that the heat leak of this tank was normal prior to lift-off. As shown in figure 2-6, the leak decreased from a high value of 15 to 20 Btu/hour to a normal 2 to 6 Btu/hour by 70 hours and remained normal thereafter. All other parameters were normal.

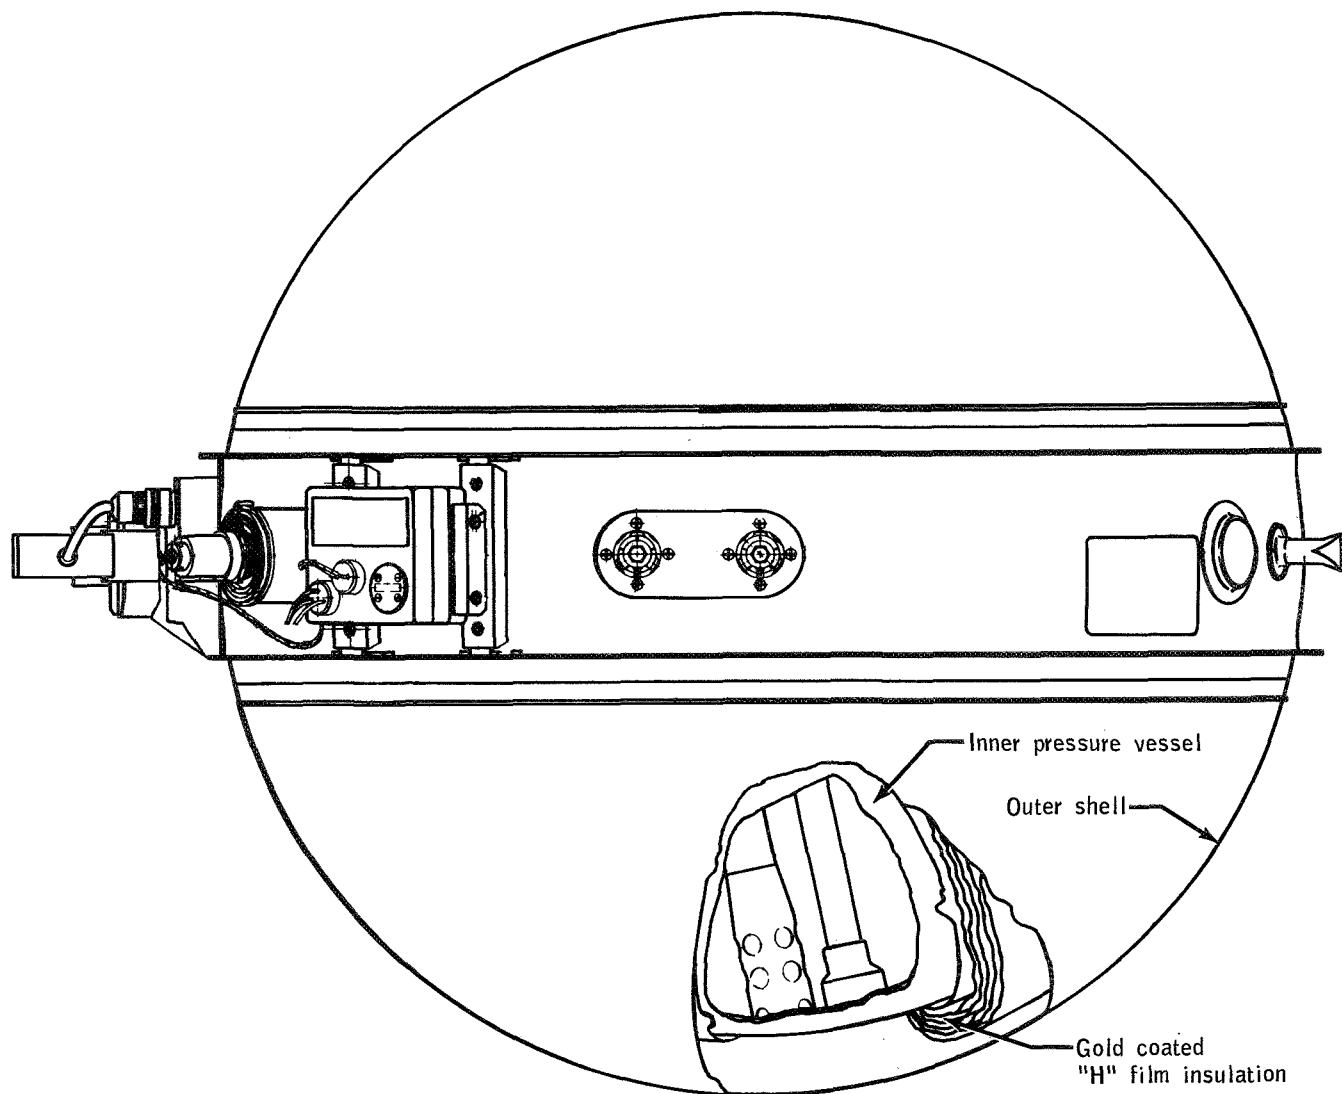
Figure 2-7.- Hydrogen tank.

The insulation for this tank consists of several layers of gold-coated H-film in a vacuum annulus that is formed between the inner pressure vessel and the outer shell (fig. 2-7). The primary insulation system is, however, the vacuum annulus. Degradation of this insulating vacuum will cause a significant increase in the heat leak into the tank as shown in figure 2-8. The analysis indicates that the high initial heat leak resulted from a degradation of this vacuum by approximately one decade (approximately 10^{-6} to 10^{-5} torr). This degradation could have been caused by either of two occurrences:

a. If thermal insulation layers rubbed against one another during the launch phase vibration, the condition could have caused the release of previously entrapped or absorbed gas molecules into the annulus.

b. An ambient air leak into the annulus could have occurred during launch.

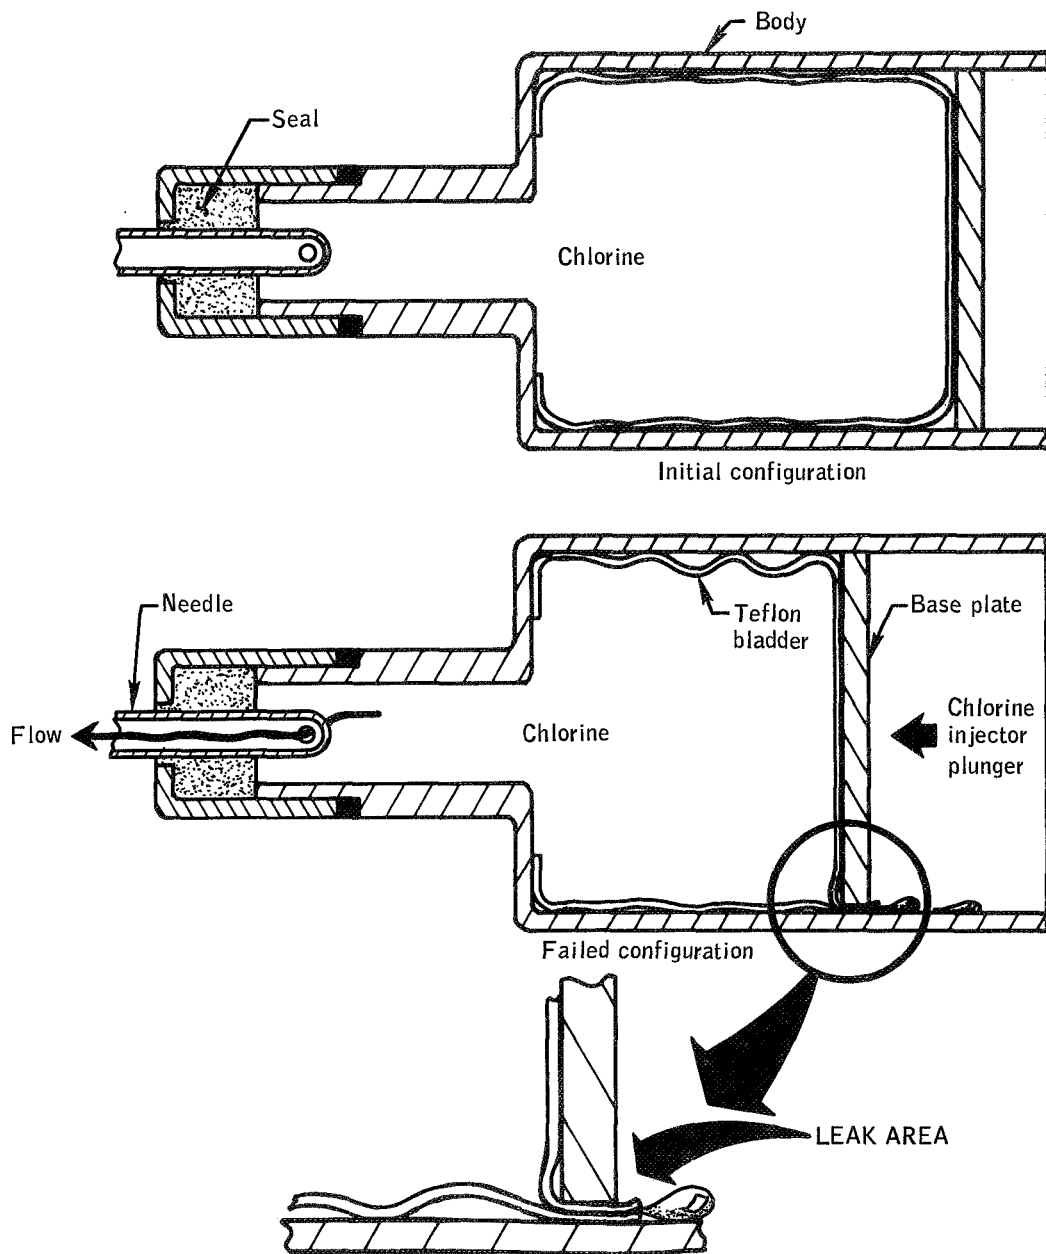
Figure 2-9.- Chlorine ampule failure.

how the Teflon bladder can be forced past the injector base plate. The outer cylinder is not sufficiently rigid to prevent the bladder from extruding around the base plate and being creased, which would be conducive to leaks.

When examined by the crew, the chlorine ampule appeared to be broken (leaking) and the inner bag was visible after having been extruded past the base plate. Inner bag extrusion has been observed before but has not been associated with leaks. The ampule was later jettisoned with the lunar module.

All ampules which were returned with the command module will be inspected for abnormalities and subjected to leak tests.

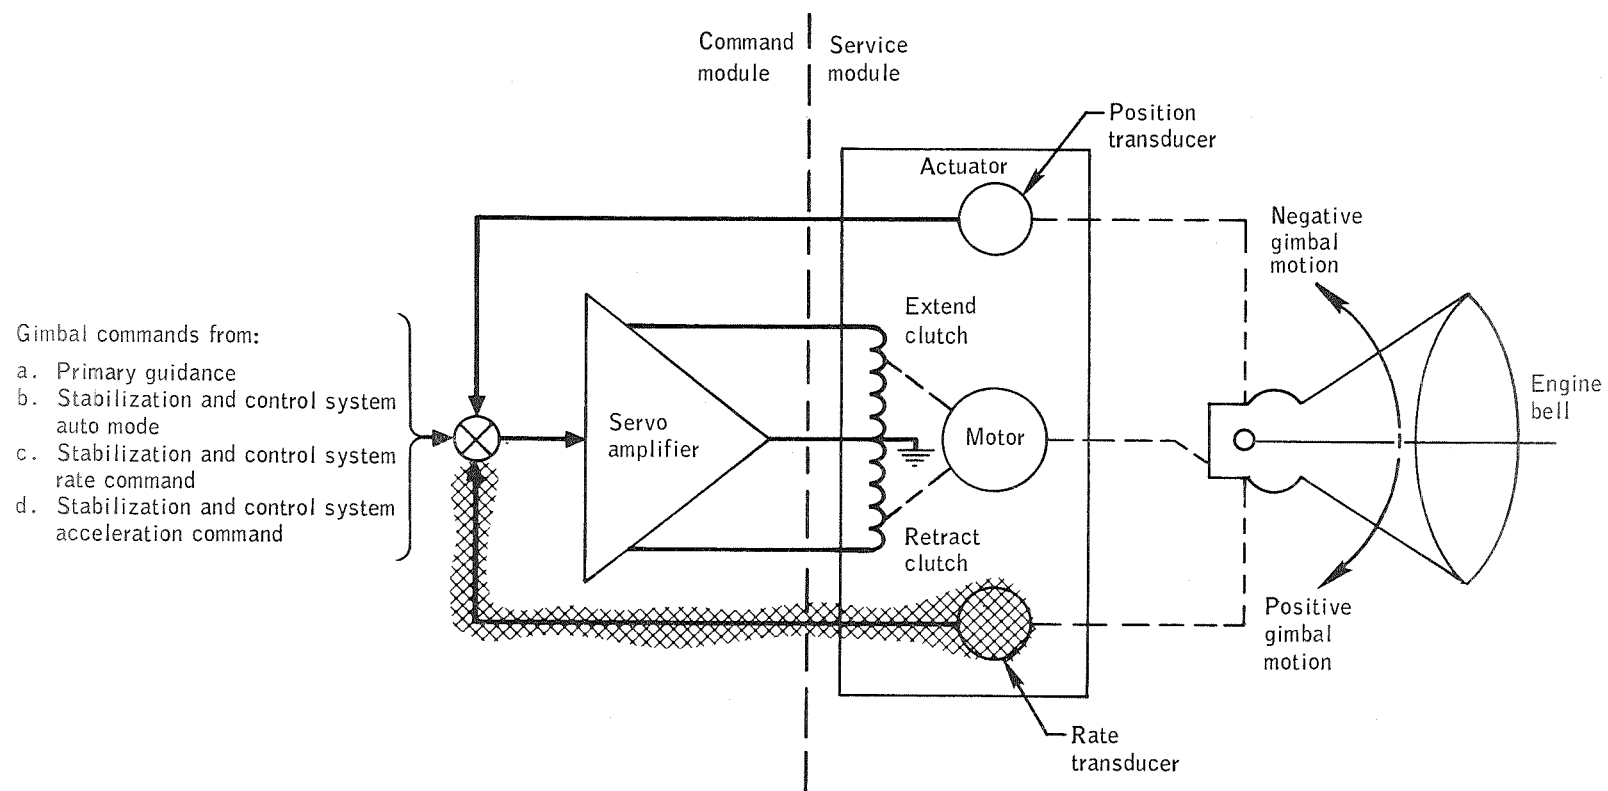
Figure 2-10.- Service propulsion system gimbal servo diagram.

Inflight results were matched by simulations of system performance with an open in the rate feedback loop of the yaw servo system. It was also demonstrated that the oscillations would have damped after ignition because of the side load forces exerted on the engine bell while thrusting. Therefore, the secondary yaw servo system was considered safe to use if the primary servo system were to fail and it became necessary to switch over to the secondary system.

Cause of the failure is an open in the rate feedback loop of the secondary yaw servo system. The open could have occurred in the rate transducer, spacecraft wiring and associated connectors, or in the thrust vector servo assembly electronics package. Postflight testing of the command module portion of the wiring and of the electronics package will be performed in an attempt to isolate the open.

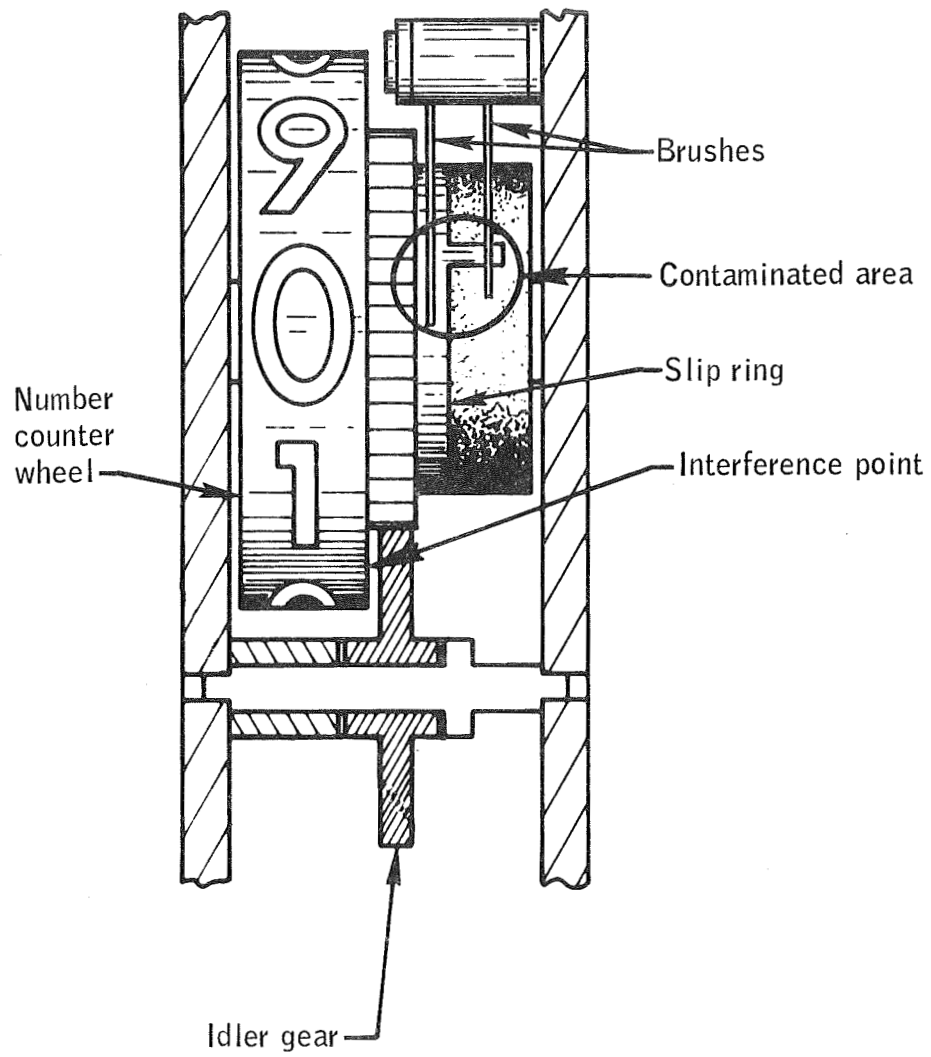
Figure 2-13.- Digital event timer seconds counter.

A similar problem occurred on Apollo 10 and was caused by nonconductive particles becoming momentarily lodged between the brushes and slip ring tabs of the counter wheels (fig. 2-13). These were paint particles from a number counter wheel which was abraided by the idler gear.

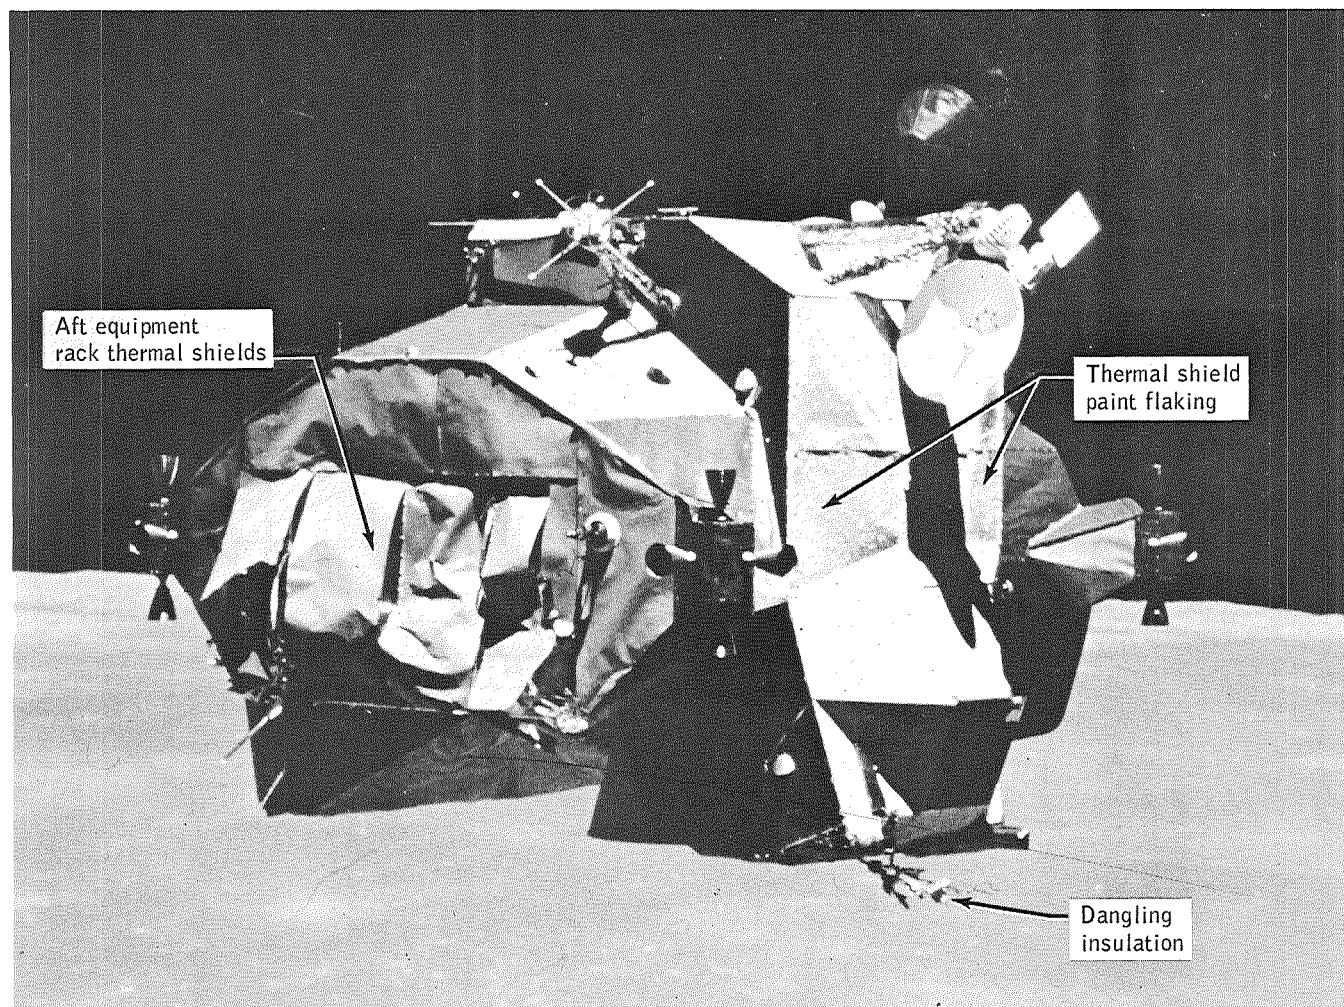
Figure 3-1.- Paint flaking and damaged thermal shield panels

Just prior to transposition and docking, particles were coming off the thermal shield panels on the minus Y side of the ascent stage. The particles caused the panels to have a grass-like appearance as shown in figure 3-1. (The aft equipment rack thermal shields and the insulation dangling from the bottom of the ascent stage shown in figure 3-1 are discussed in section 3.2.) The paint flakes interfered with star sightings and were potential optical surface contaminants. Thermal tests conducted on specimens removed from a lunar module panel demonstrated that the paint on the panels starts to peel at approximately minus 120° F. The predicted minimum temperature of the panels during the mission is minus 270° F.

At lunar lift-off, four vertical thermal shields (fig. 3-1) on the aft equipment rack were torn loose from the lower standoffs and remained attached only at the upper standoffs. This occurrence was observed from the lunar-based television.

Photographs of the ascent stage taken prior to rendezvous docking (fig. 3-1) show insulation hanging from the plus Y base heat shield. An examination of photographs indicates that the most probable source of the insulation is the thermal shield blanket covering the descent stage blast deflector. This shield is normally blown off during ascent engine ignition; therefore, no corrective action is required for this condition.

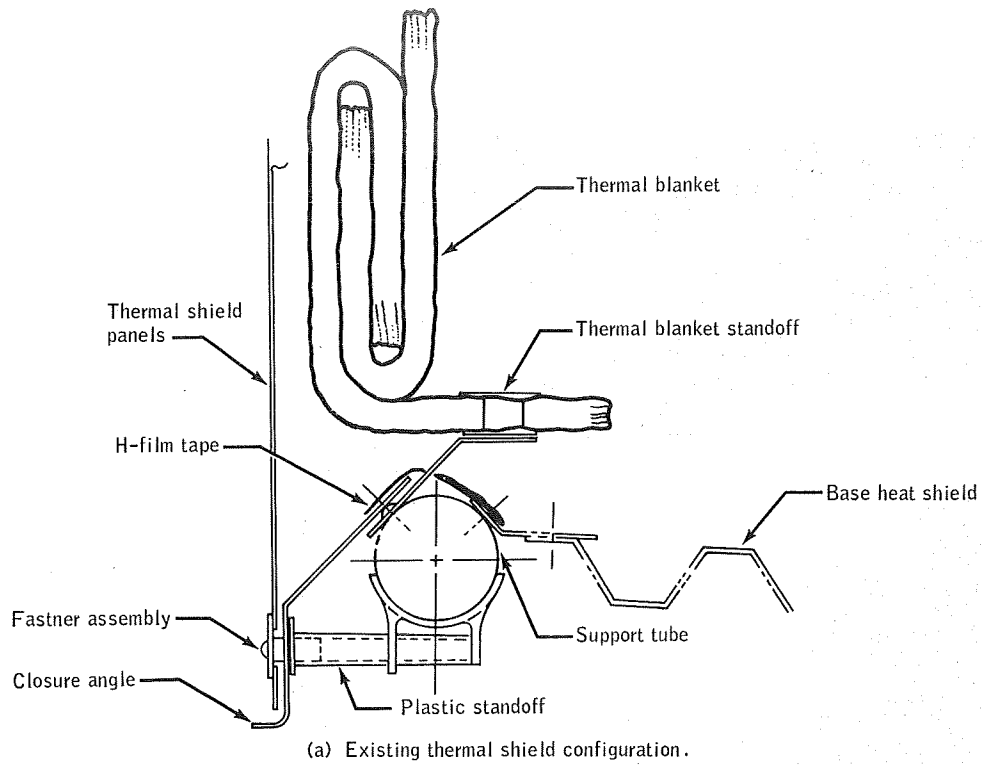
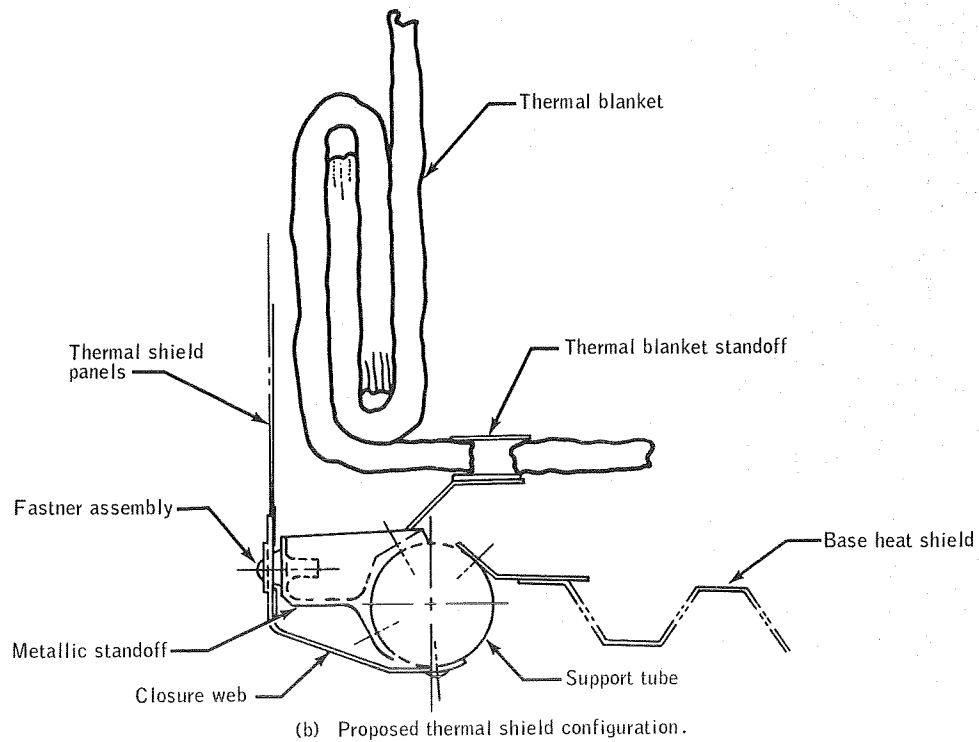
Figure 3-2.- Aft equipment rack thermal protection configuration.

The most probable cause of the failure was ascent engine exhaust entering the cavity behind these thermal shields. A cross section of the lower edge of the shields is shown in figure 3-2. The thermal shield extending below the support tube allowed a pressure buildup on the closure shield which exceeded its capability. Once the closure shield failed, the exhaust entered the cavity behind the shield, resulting in a pressure buildup exceeding the capability of the vertical thermal shields.

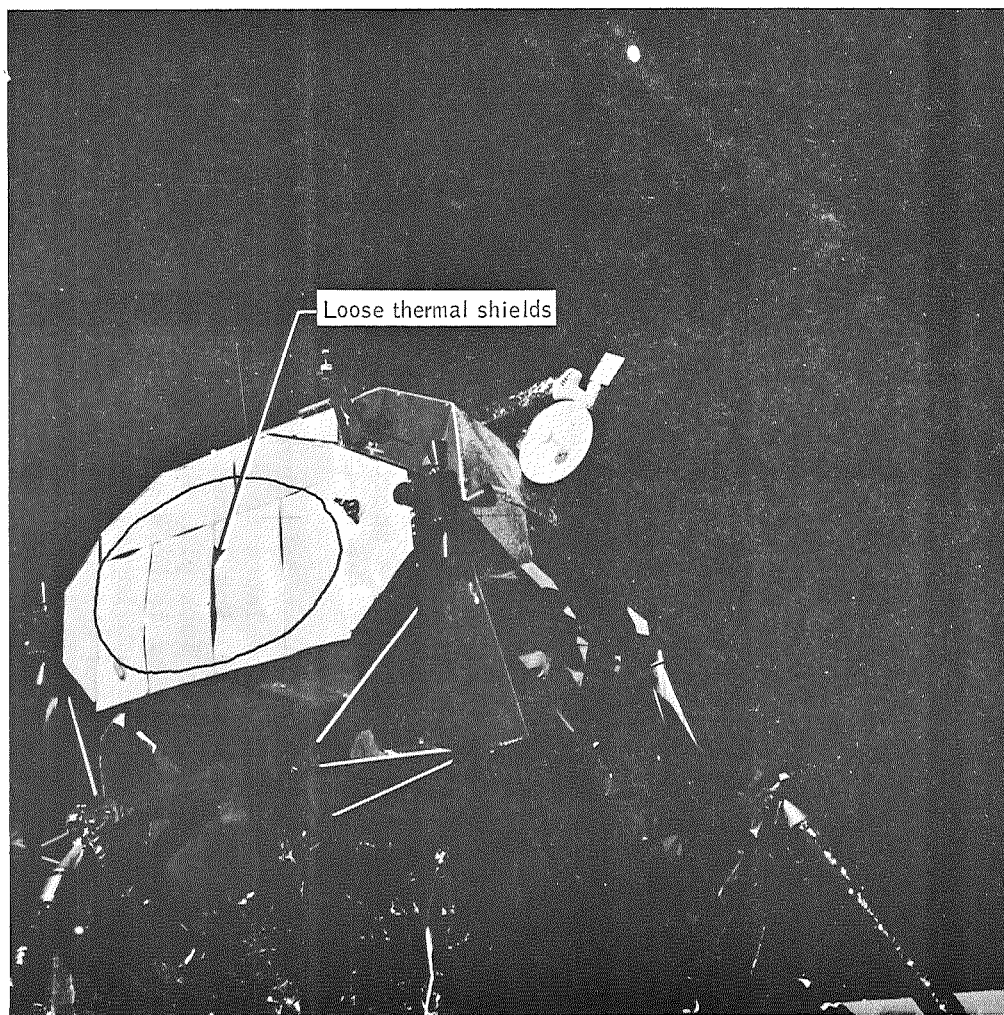
Figure 3-3.- Aft equipment rack thermal shields loose at center standoff.

In the lunar surface photographs taken prior to lift-off, some of the shields appear to have come loose from the center standoff (fig. 3-3). Excessive gaps between some of the panels are evident. Both conditions could be caused by excessive pressure in the thermal blanket due to insufficient venting during boost.

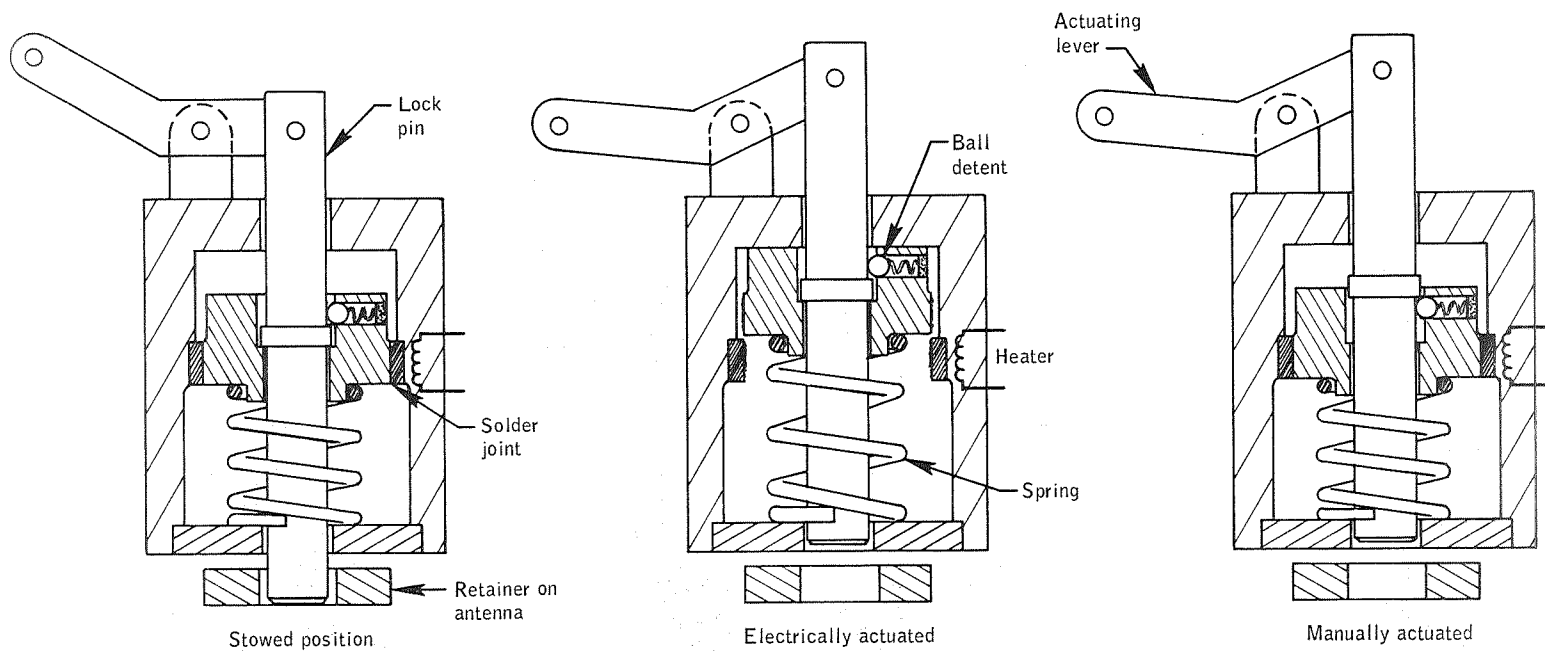
Figure 3-5.- Stow latch mechanism.

Photographs and inflight test data show that the problem was caused by failure of the mechanical stow latch to release. Functionally, the stow latch restrains the antenna during launch. Figure 3-5 shows the functional operation of the latch. The lock pin, when extended, holds the antenna in the stowed position. A spring is held under compression by a sleeve which is constrained to the latch housing by solder. Melting the solder allows the spring to push the sleeve which, in turn, raises the lock pin out of the retainer. A manual mode is provided for checkout purposes. The lever (fig. 3-5) will pull the lock pin past the ball detent, thus releasing the antenna without disturbing the spring-sleeve-solder configuration.

Antenna photographs, taken on the lunar surface and in lunar orbit prior to docking indicate that the lever for the yaw axis latch was still in the locked position. The crew noted a 2- to 3-degree movement of the yaw indicator during activation attempts. Tolerances in the antenna retainer/locking mechanism allow a slight movement of the antenna dish even though the pin is locked. This condition was duplicated in ground tests, and is normal for a stowed antenna.

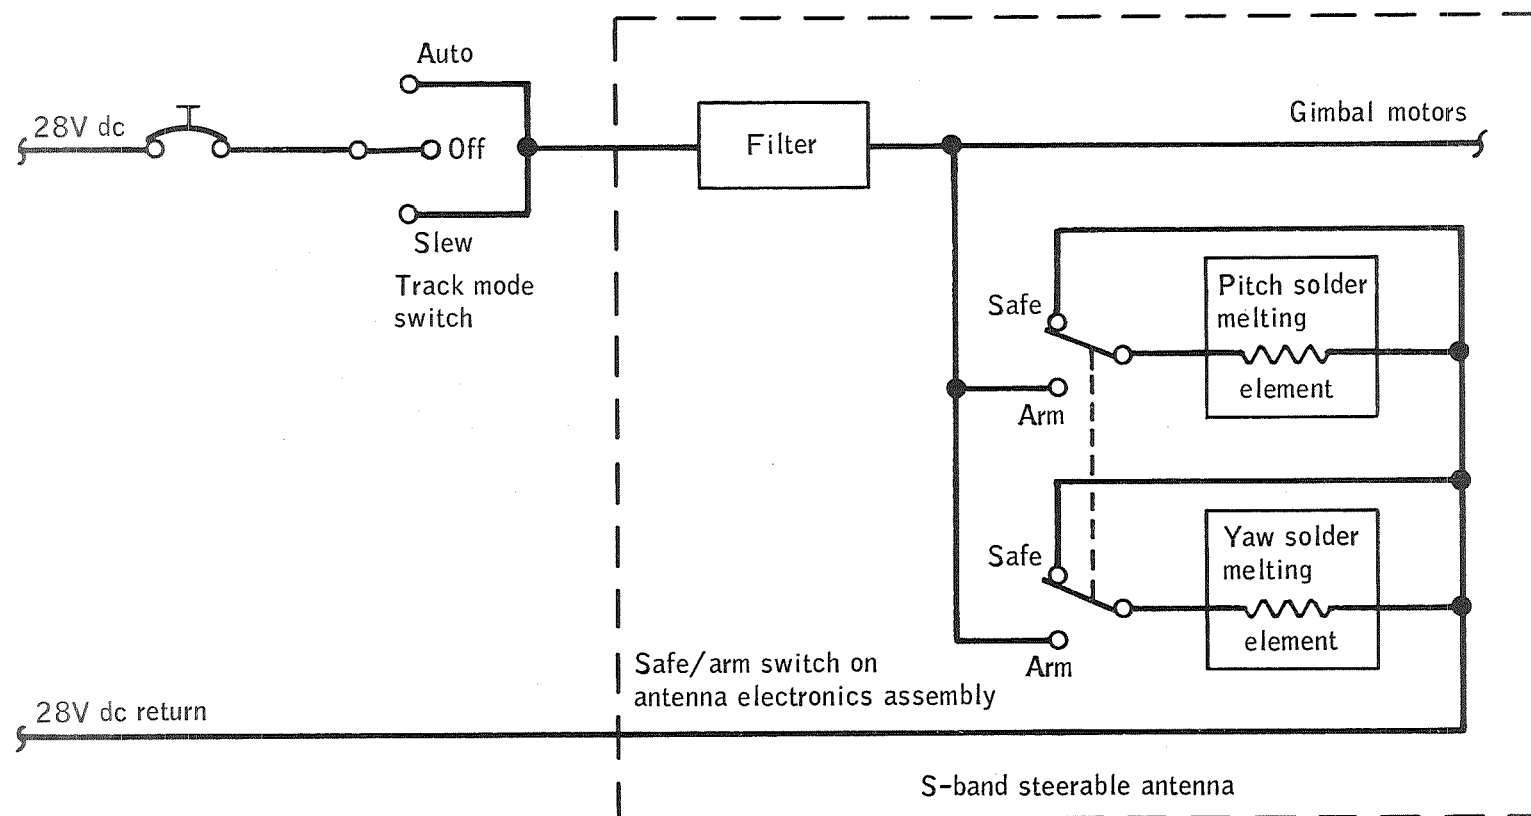
Figure 3-6.- Lunar module steerable antenna stow-latch circuit.

There are several areas in the electrical circuitry which could have caused the problem. One is that one contact in the safe/arm switch (figure 3-6) did not make. The second is that an open may have existed downstream of the safe/arm switch, either in the solder melting element or in the wiring back through ground. A resistance measurement is made across the two parallel solder-melting elements prior to flight. About a 3-ohm increase in resistance was found at the last check. This change is equivalent to about a 10-ohm increase in one of the elements which could have been indicative of this problem. Mechanically, the only reasonable failure for this design would be a missing spring or snap ring. The records show no difficulties or problems associated with the entire assembly.

Several corrective actions are planned to cover all reasonable possibilities of failure. These include:

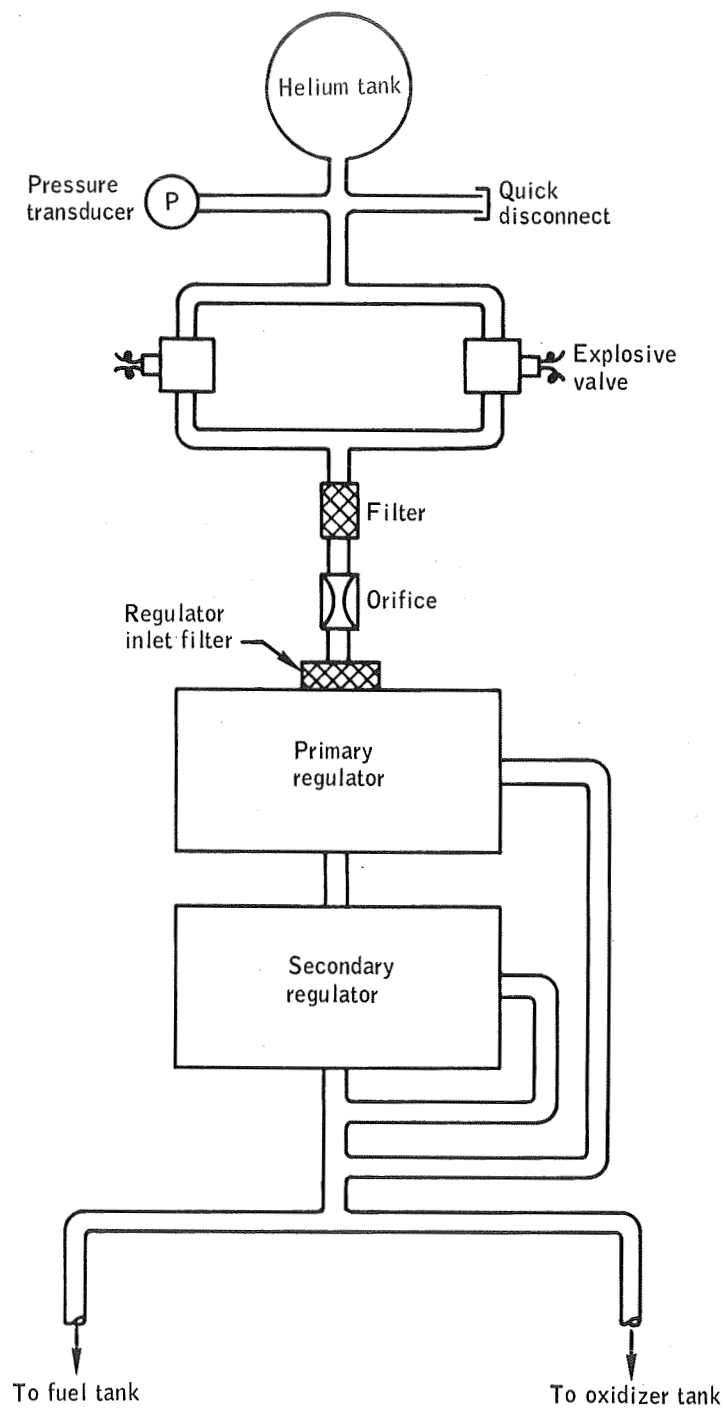
Figure 3-7.- Reaction control system pressurization system.

During pressurization of the system at about 95:00, the regulator outlet pressure in system A (fig. 3-7) increased beyond the maximum specification limit. The normal pressurization is characterized by a sharp increase from the nominal pad pressure, in the interval of 1 to 2 seconds, to the normal regulator outlet pressure. The outlet pressure of system A, after reaching the normal value of 184 psia, continued to rise at approximately 10 psi/minute, a condition which clearly indicated the existence of internal leakage in the regulator assembly. The helium leakage continued throughout the mission, although the leakage rate varied from essentially zero to a maximum of about 1100 scc/min (figs. 3-8 and 3-9). The regulator outlet pressure eventually increased to about 237 psia at which time the relief valves of system A started to periodically relieve the pressure to about 232 psia.
